TWR-17371

Space Shuttle Development Motor No. 9 (DM-9) Final Test Report

September 1990

Thiokol CORPORATION
SPACE OPERATIONS

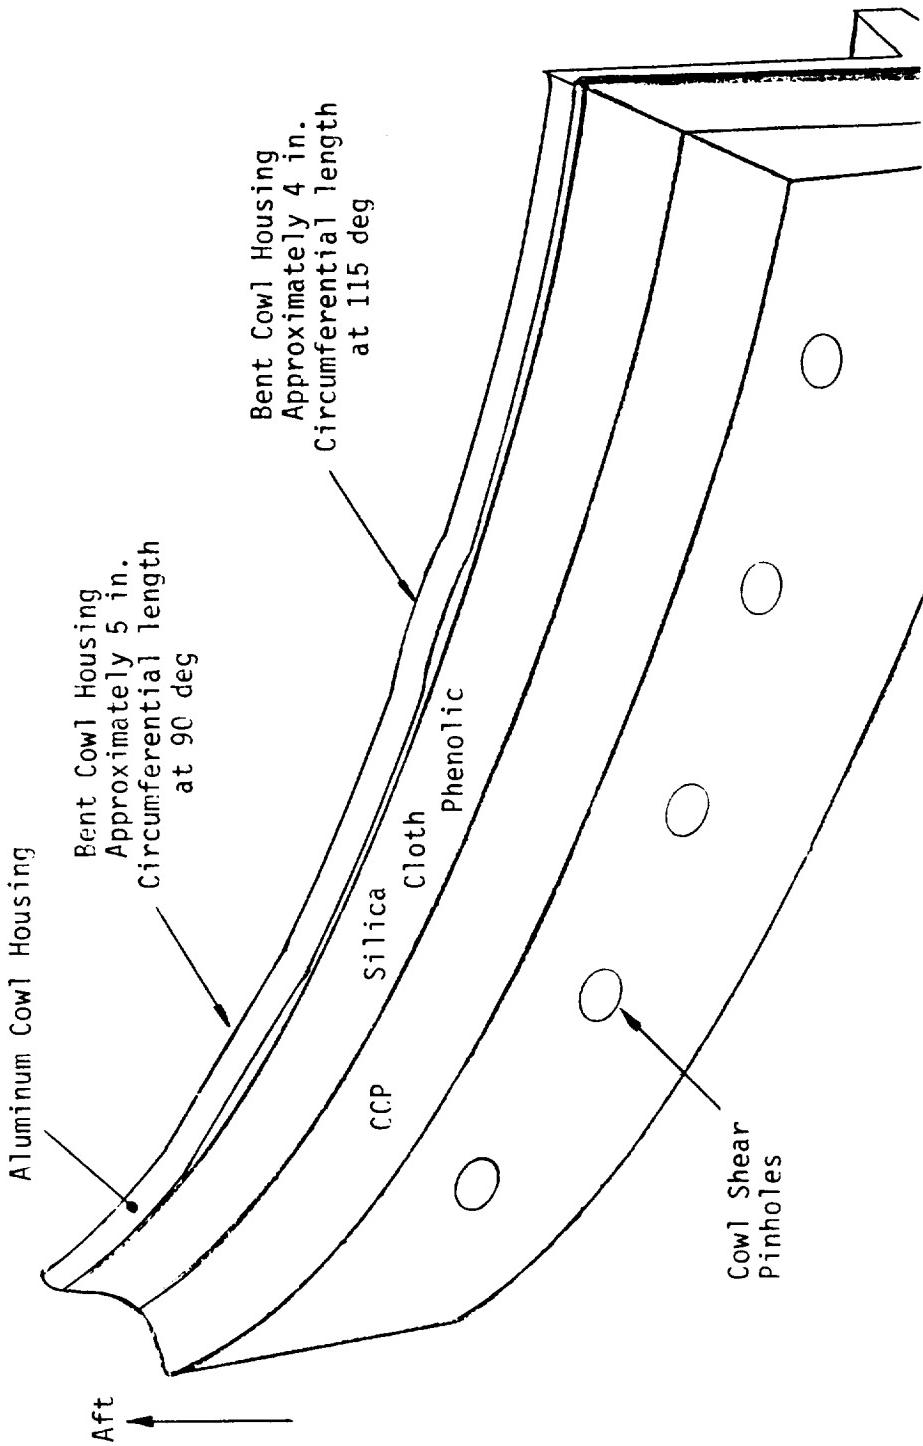
Figure 7.5-69. DM-9 Aluminum Cowl Housing Damage

Bondline separations at the cowl housing aft end occurred only in line with the metal damage located at 90 and 115 deg. The separations failed cohesively within the EA 913 adhesive and adhesively between the housing and adhesive. There were no bondline separations observed at the cowl housing forward end.

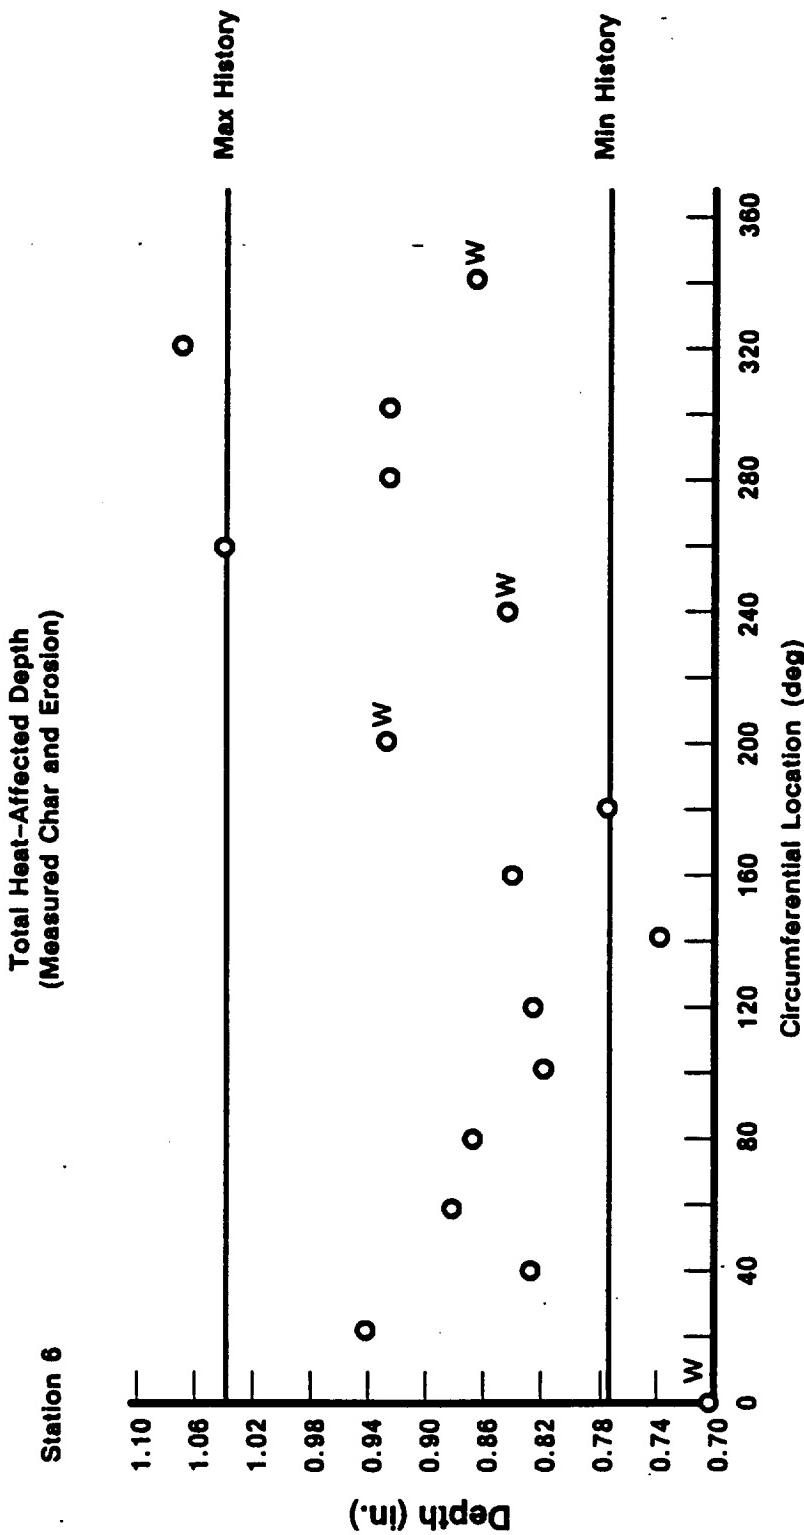
Figure 7.5-71. DM-9 Total Material Affected Depths for Cowl Aft End (Station 6)

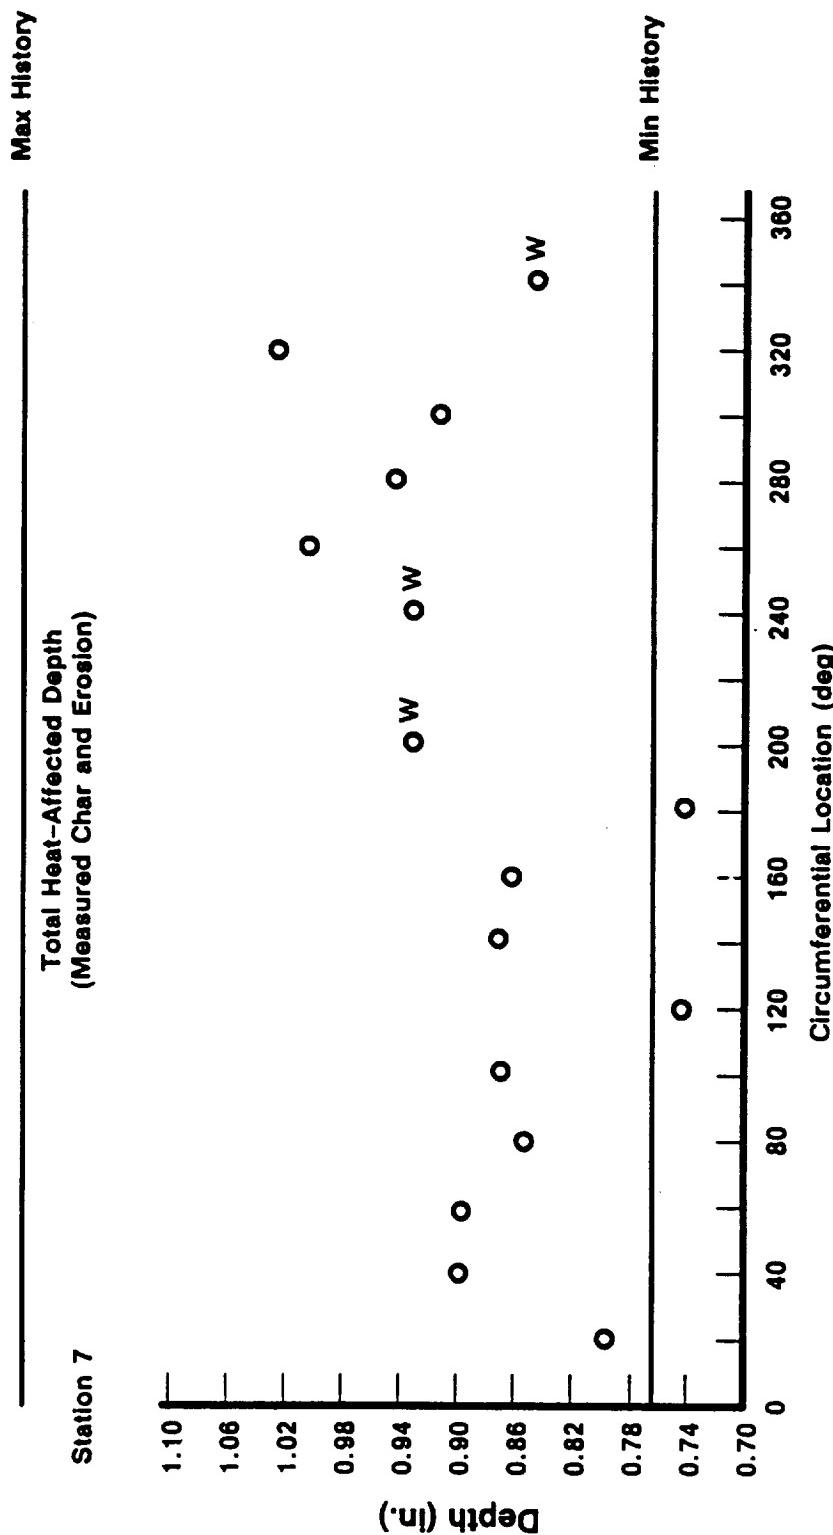
Figure 7.5-72. DM-9 Total Material Affected Depths for Cowl Aft End (Station 7)

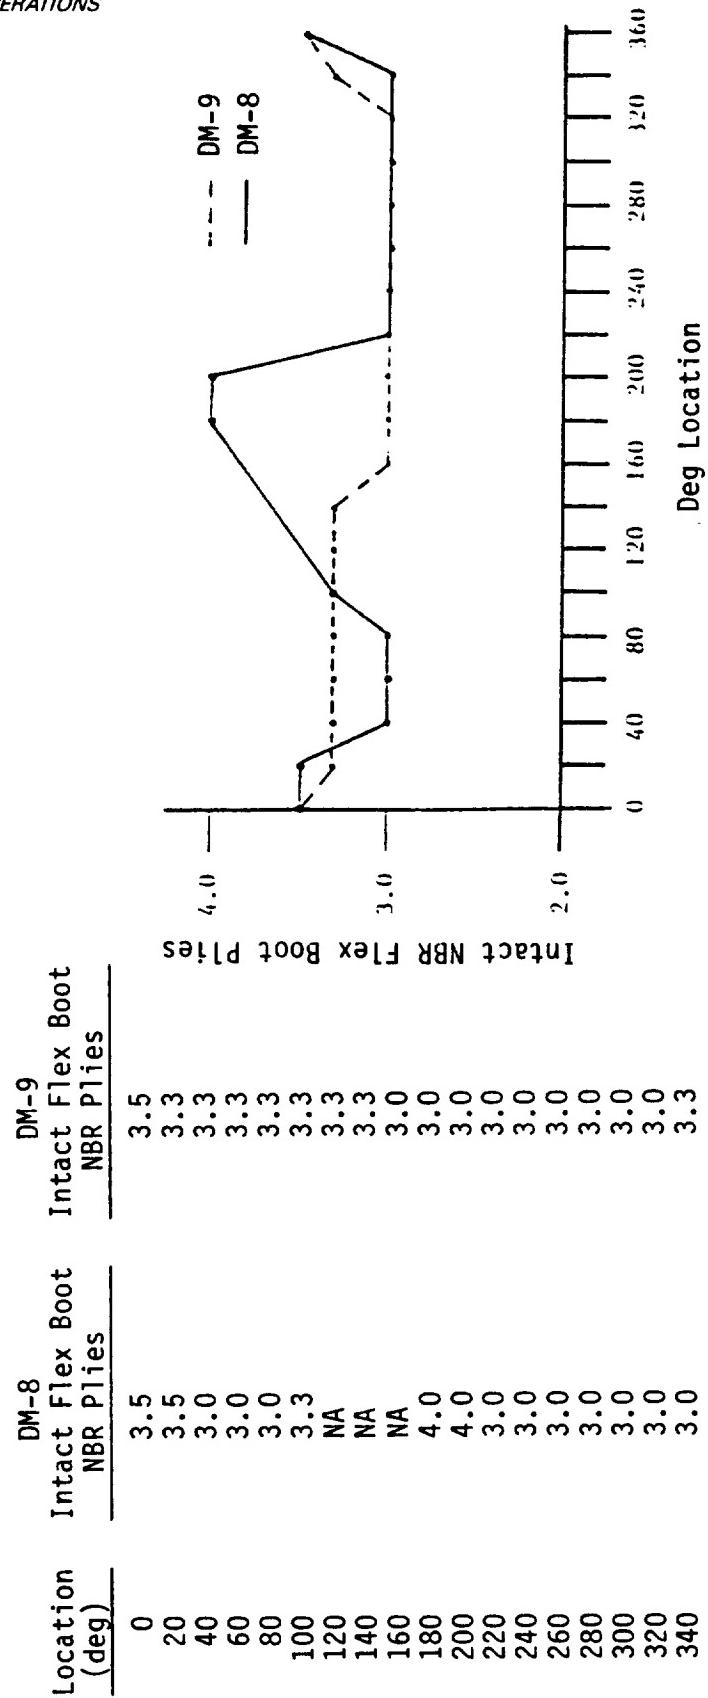
Figure 7.5-73. DM-9 and DM-8 Flex Boot Remaining NBR Plies

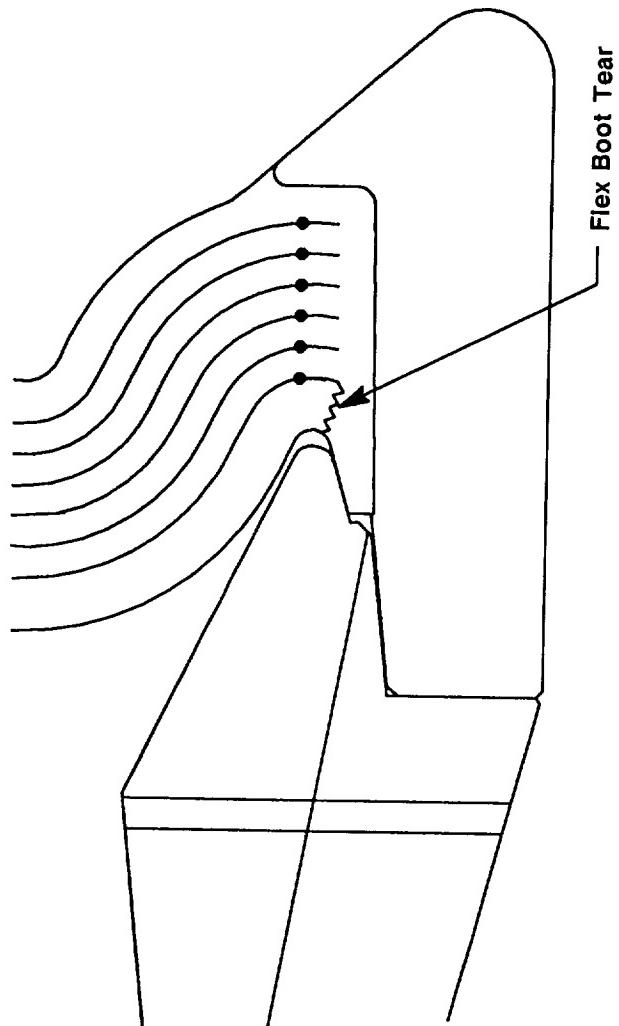
Partial tears were observed near the flex boot OD forward tip at 20 and 200 deg (Figure 7.5-77). Complete breaks through the flex boot OD forward tip appeared from

Figure 7.5-77. DM-9 Flex Boot Tears Located at 20 and 200 deg

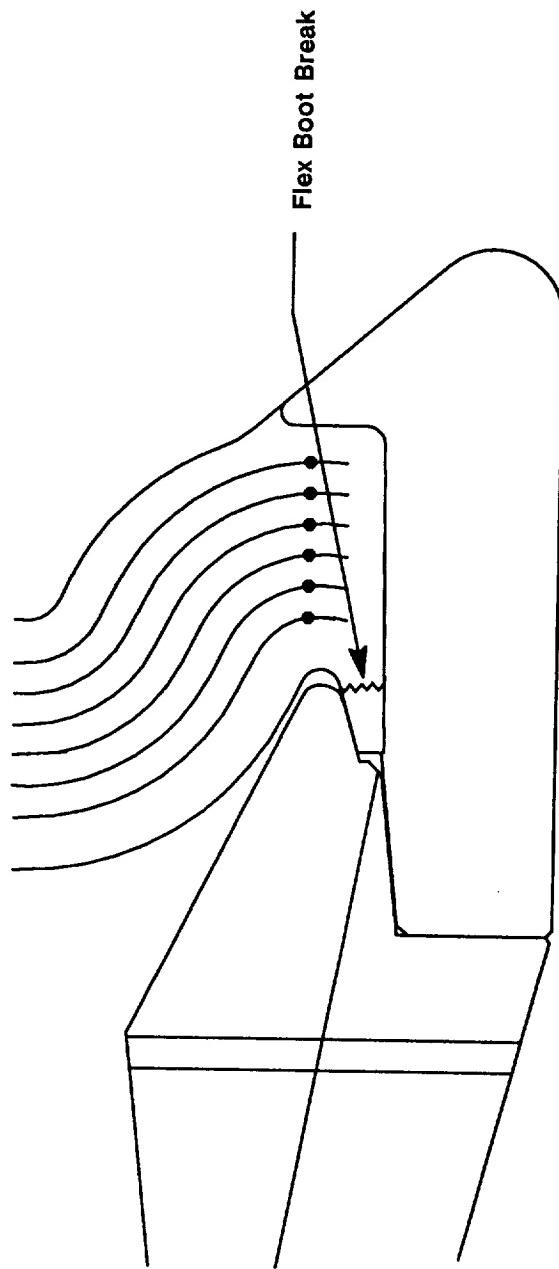
240 to 300 deg (Figure 7.5-78). The flex boot OD forward tip remained bonded to the cowl ring where the complete breaks occurred.

Figure 7.5-78. DM-9 Flex Boot Breaks Located From 240 to 300 deg

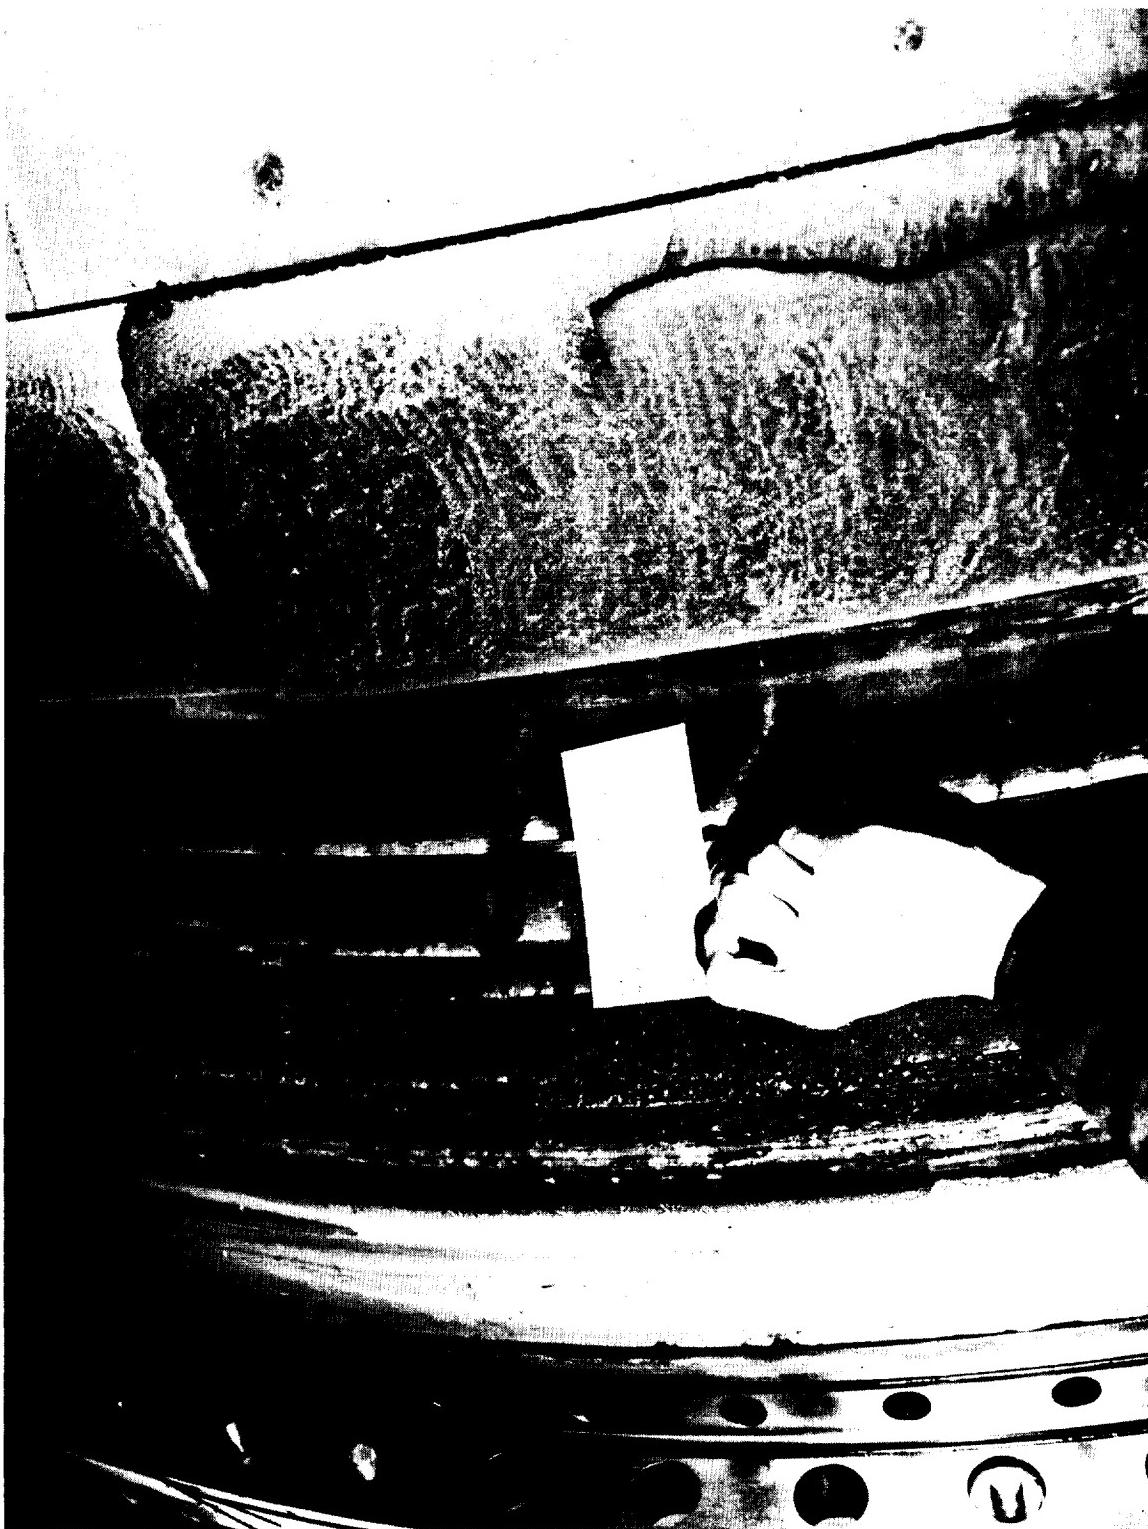
The fixed housing insulation erosion was smooth and uniform. Photographs of the fixed housing insulation are shown in Figures 7.5-9 through 7.5-12 and 7.5-81. Wide post-test delaminations and heavy slag deposits were observed at the aft end of the CCP insulation. The fixed housing insulation flow surface showed no impact marks. Housing bondlines at the inner boot ring forward end and at the fixed housing insulation aft end were intact.

Figure 7.5-81. DM-9 Fixed Housing Insulation (60 deg)

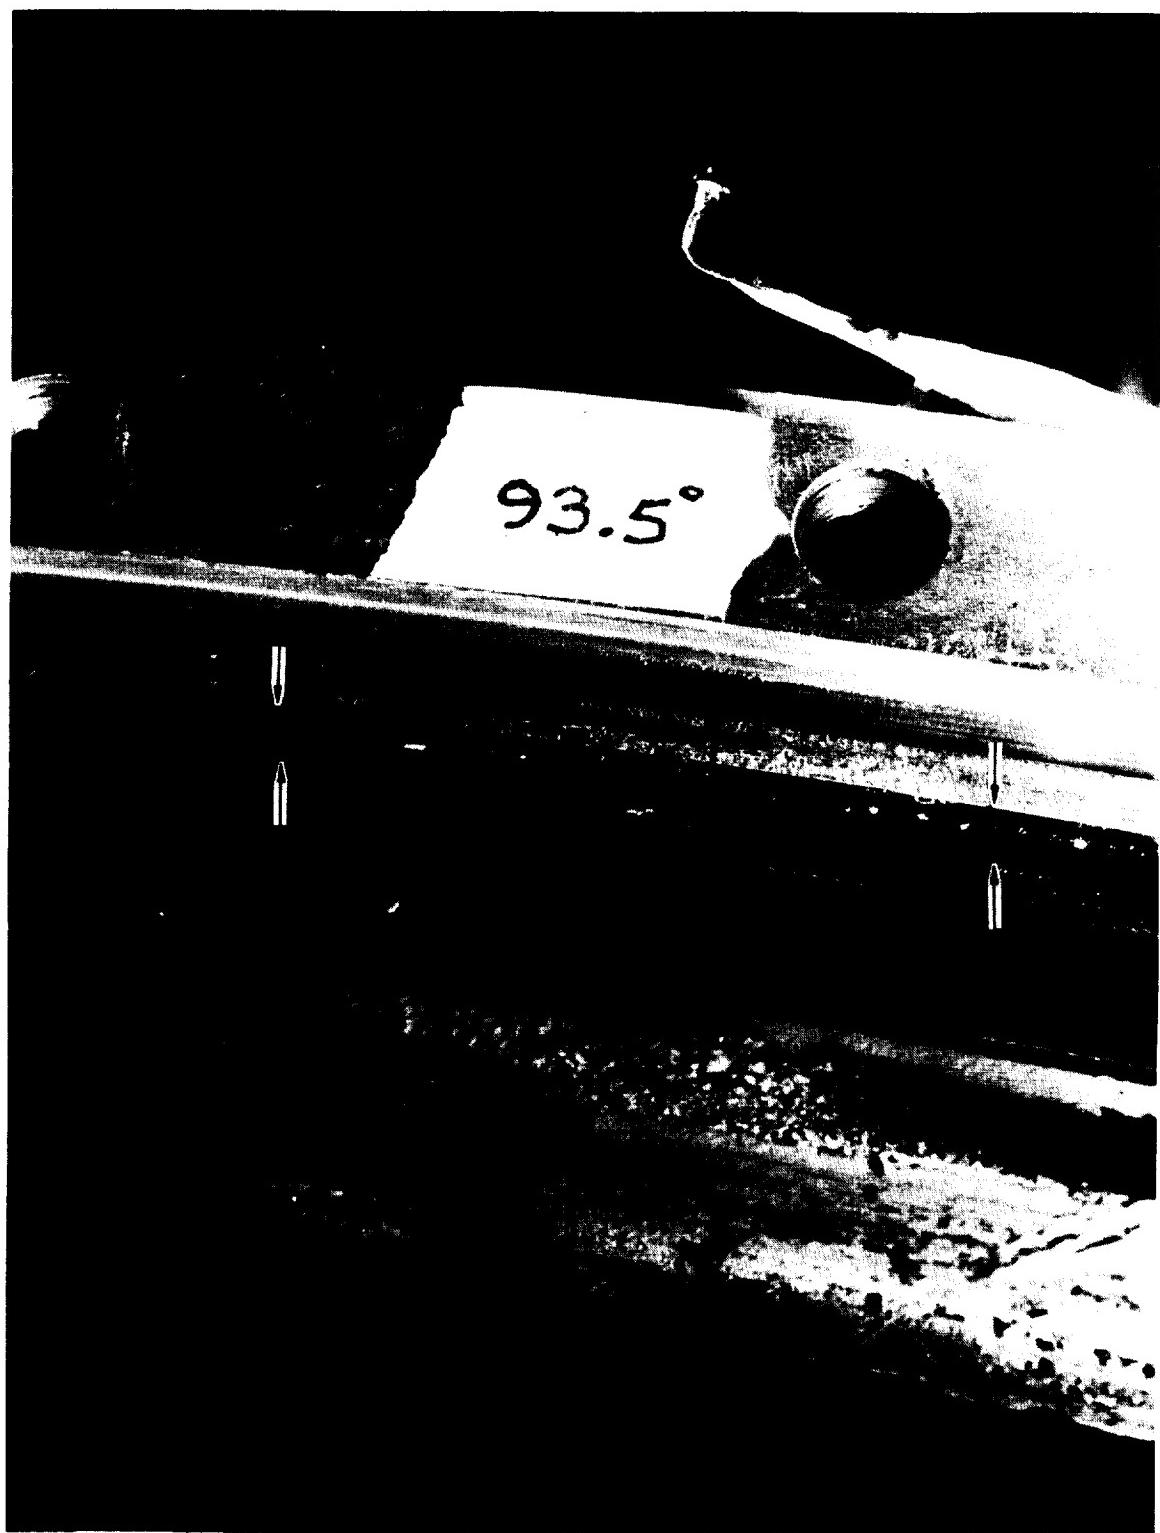
Figures 7.5-82 through 7.5-83 show views of the polysulfide backfill at the forward aluminum shell bondline. No adhesive failure was evident between the polysulfide and housing or between the polysulfide and GCP overwrap. The surface bubbles/voids within the polysulfide were present in the pretest. There was no evidence of flow within or adjacent to the shell bondline.

Figure 7.5-82. DM-9 Aft Exit Cone Polysulfide Backfill (93 deg)

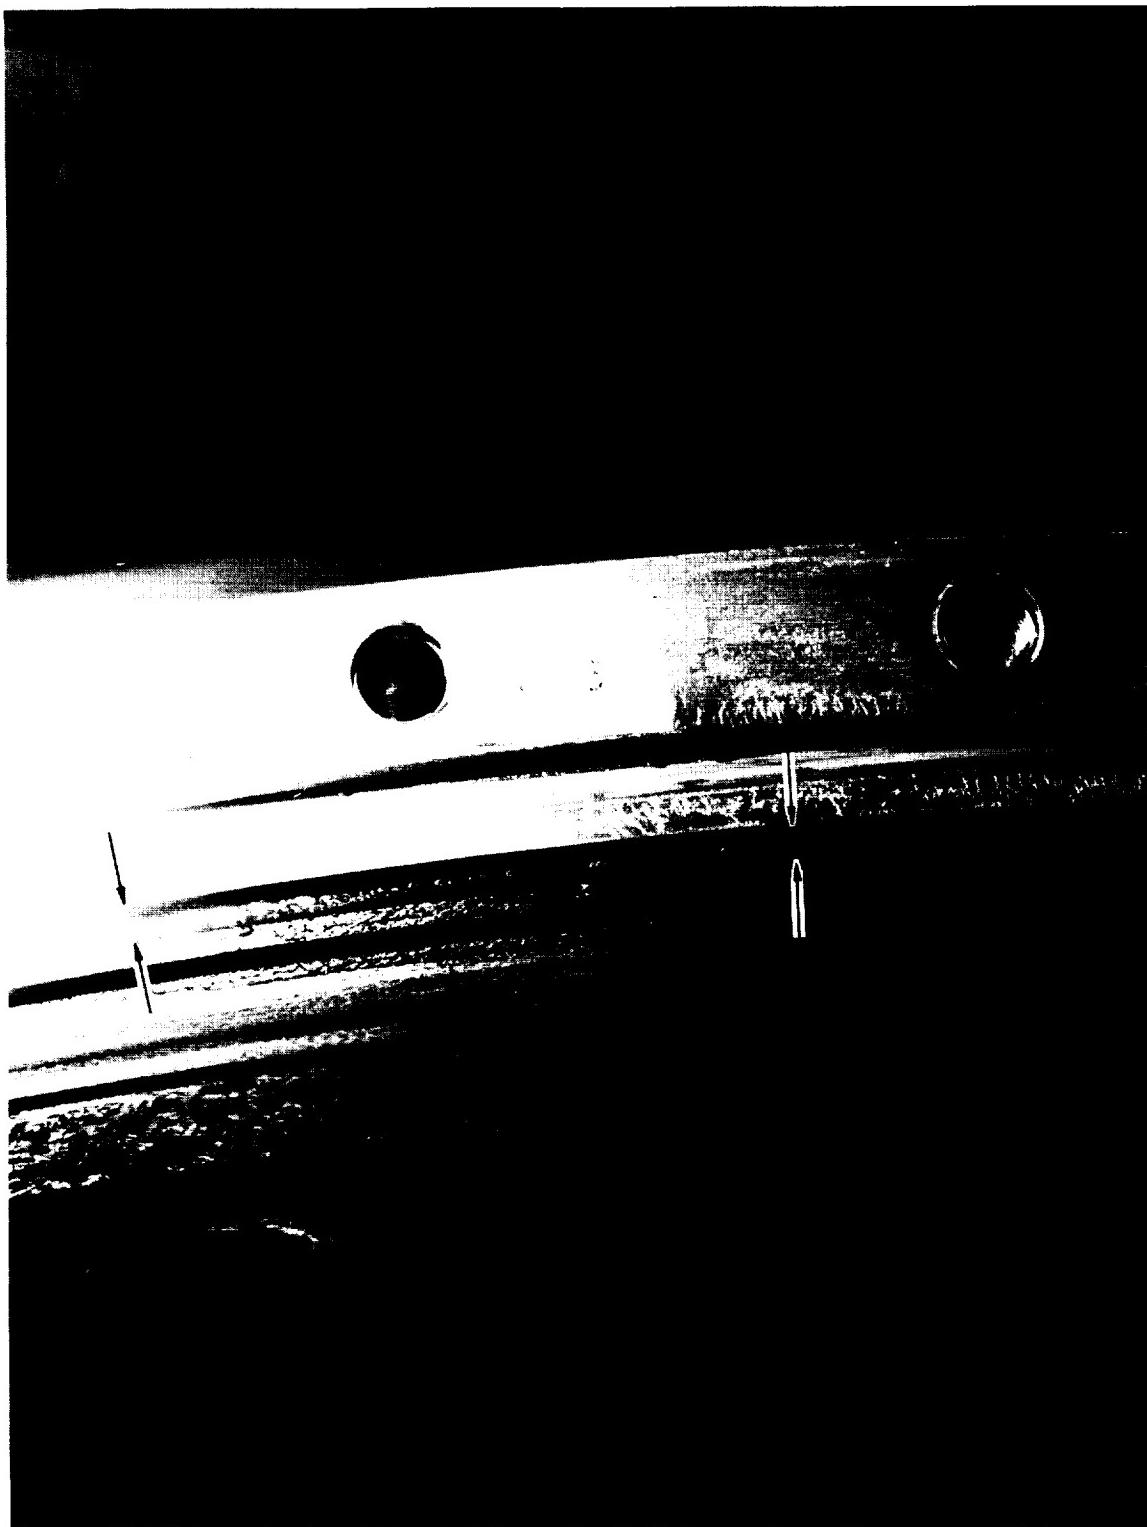
Figure 7.5-83. DM-9 Aft Exit Cone Polysulfide Backfill (265 deg)

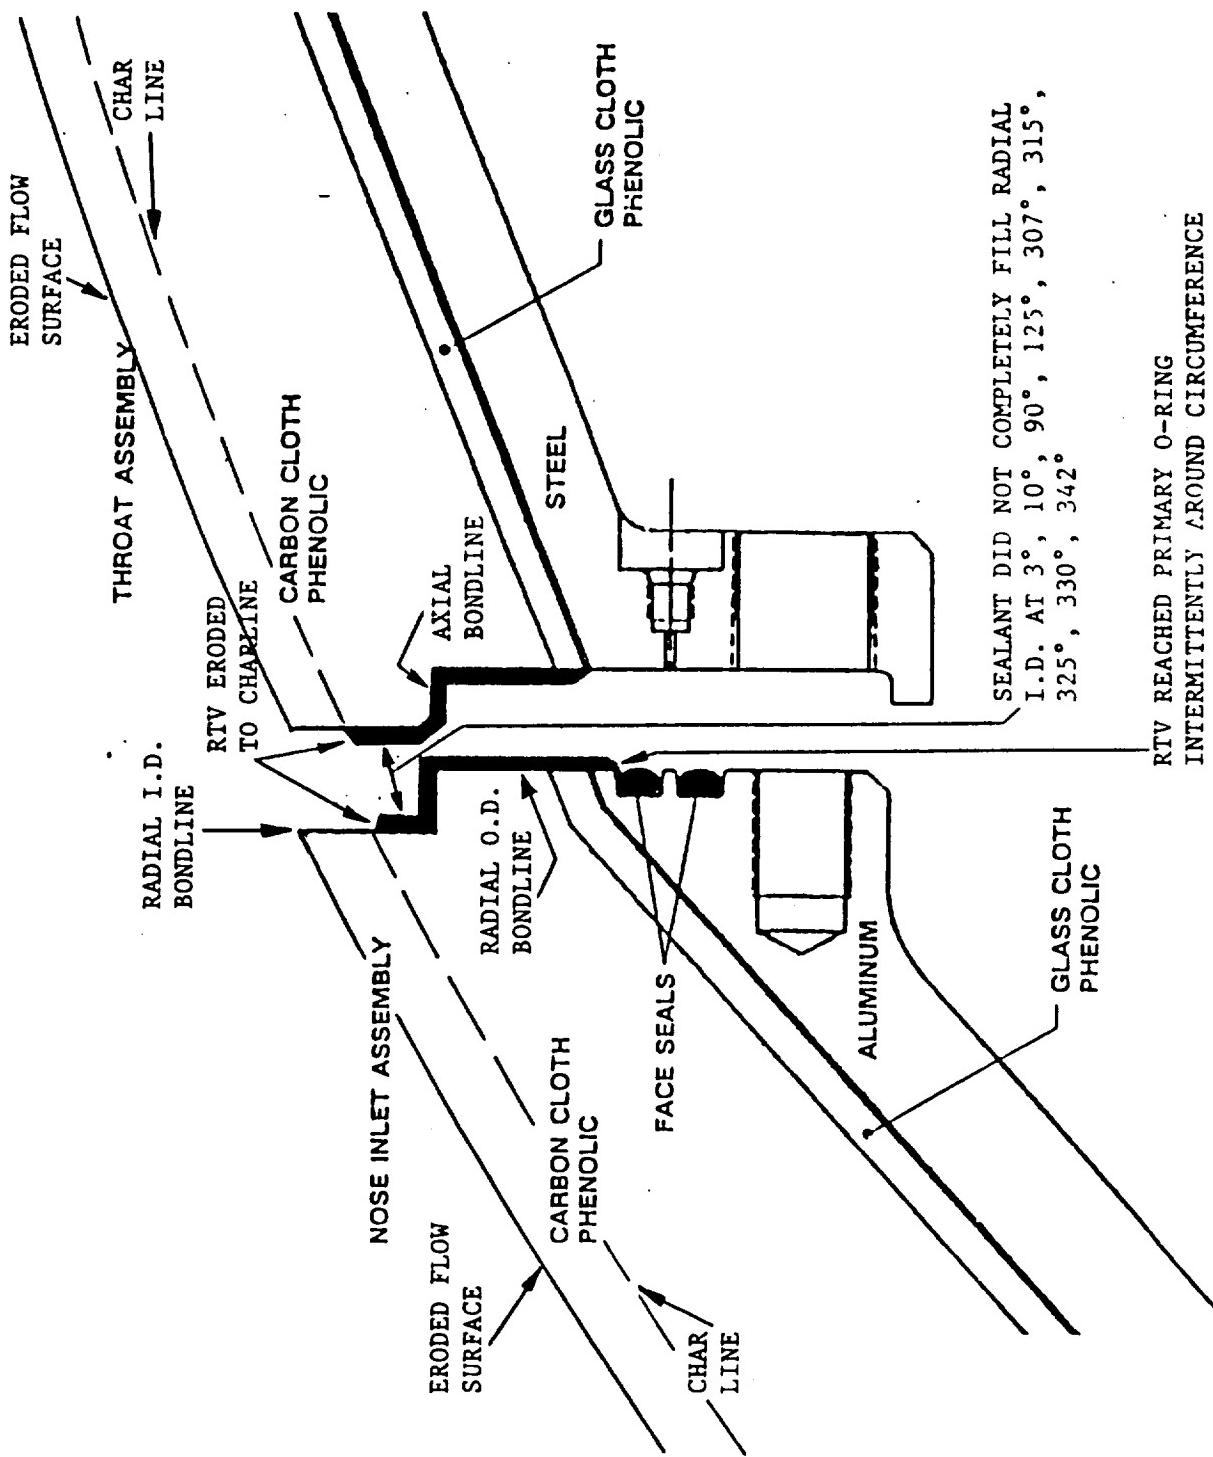
The backfilled RTV sealant extended below the joint char line 360 deg circumferentially. The sealant did not completely fill the radial ID portion of the bondline at 3, 10, 90, 125, 307, 315, 325, 330, and 342 deg. The RTV sealant extended past the axial portion of the bondline from 0 to 2, 15 to 20, 25 to 50, 55 to 88, 112 to 118, 175 to 185, 190 to 195, 200 to 208, 215 to 290, 300 to 305, and 338 to 340 deg. RTV reached the high-pressure side of the primary O-ring intermittently around the

Figure 7.5-84. DM-9 Post-Test Nose Inlet/Throat Assembly Joint

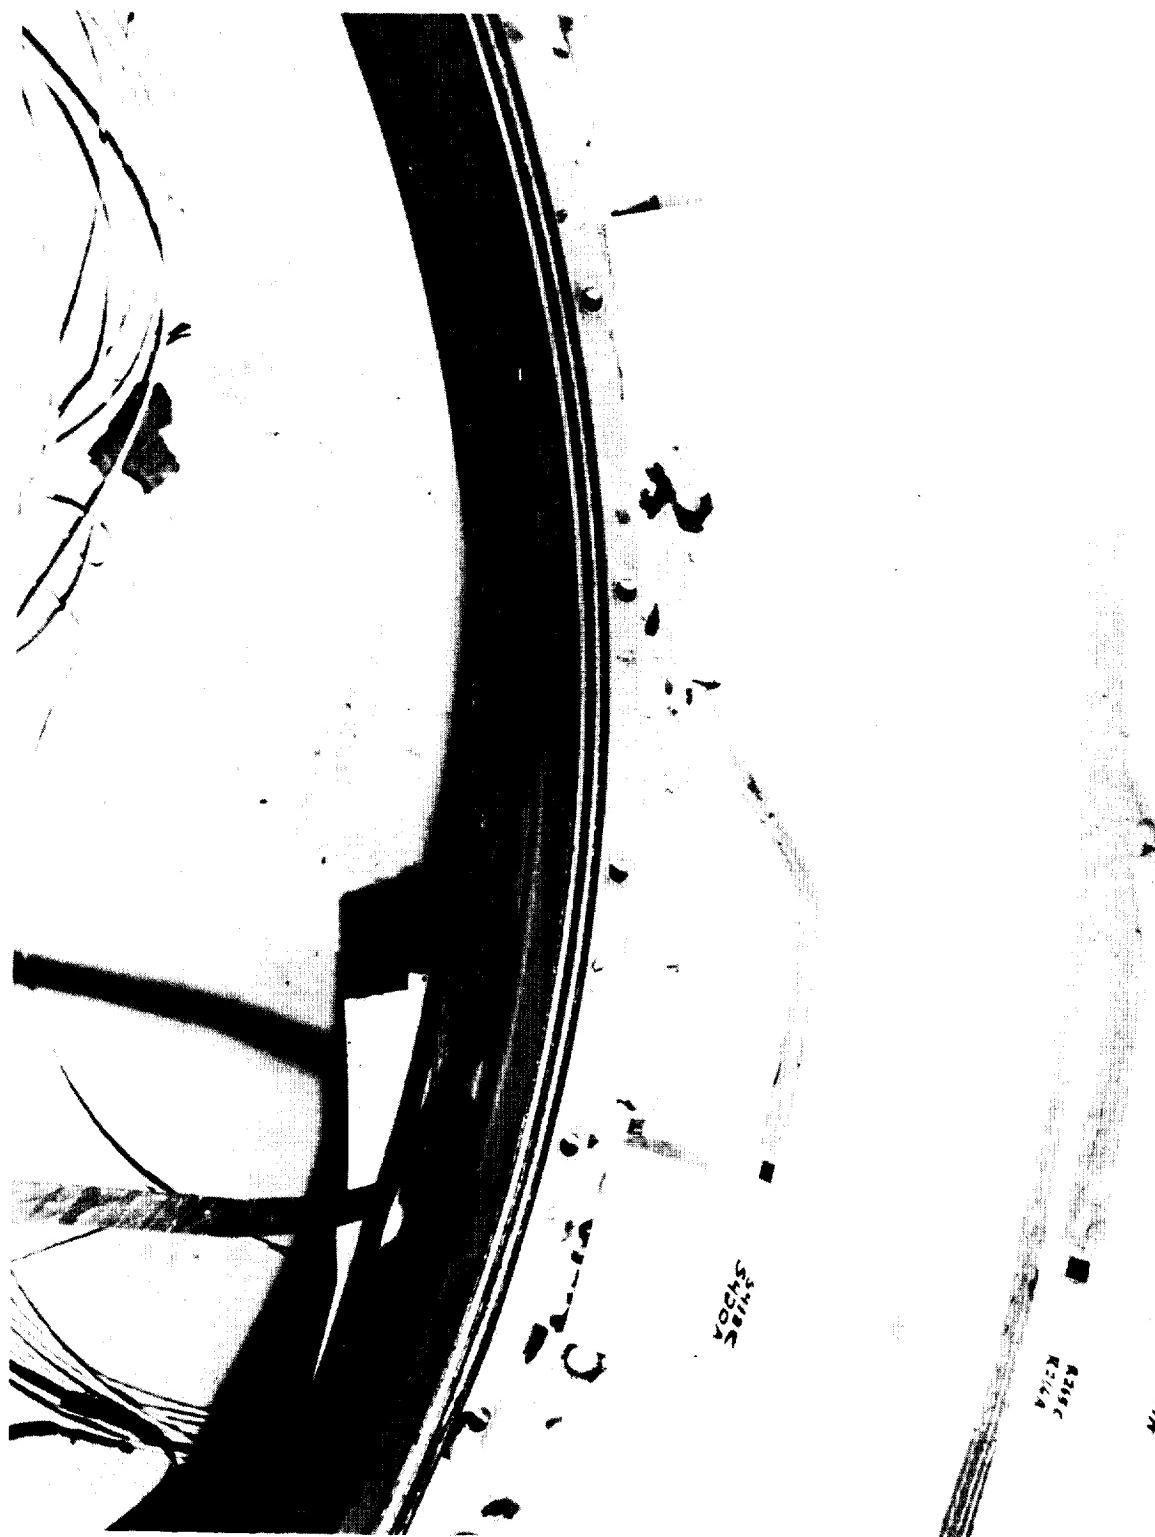
Figure 7.5-85. Nose Inlet/Throat Joint (0-30 deg)

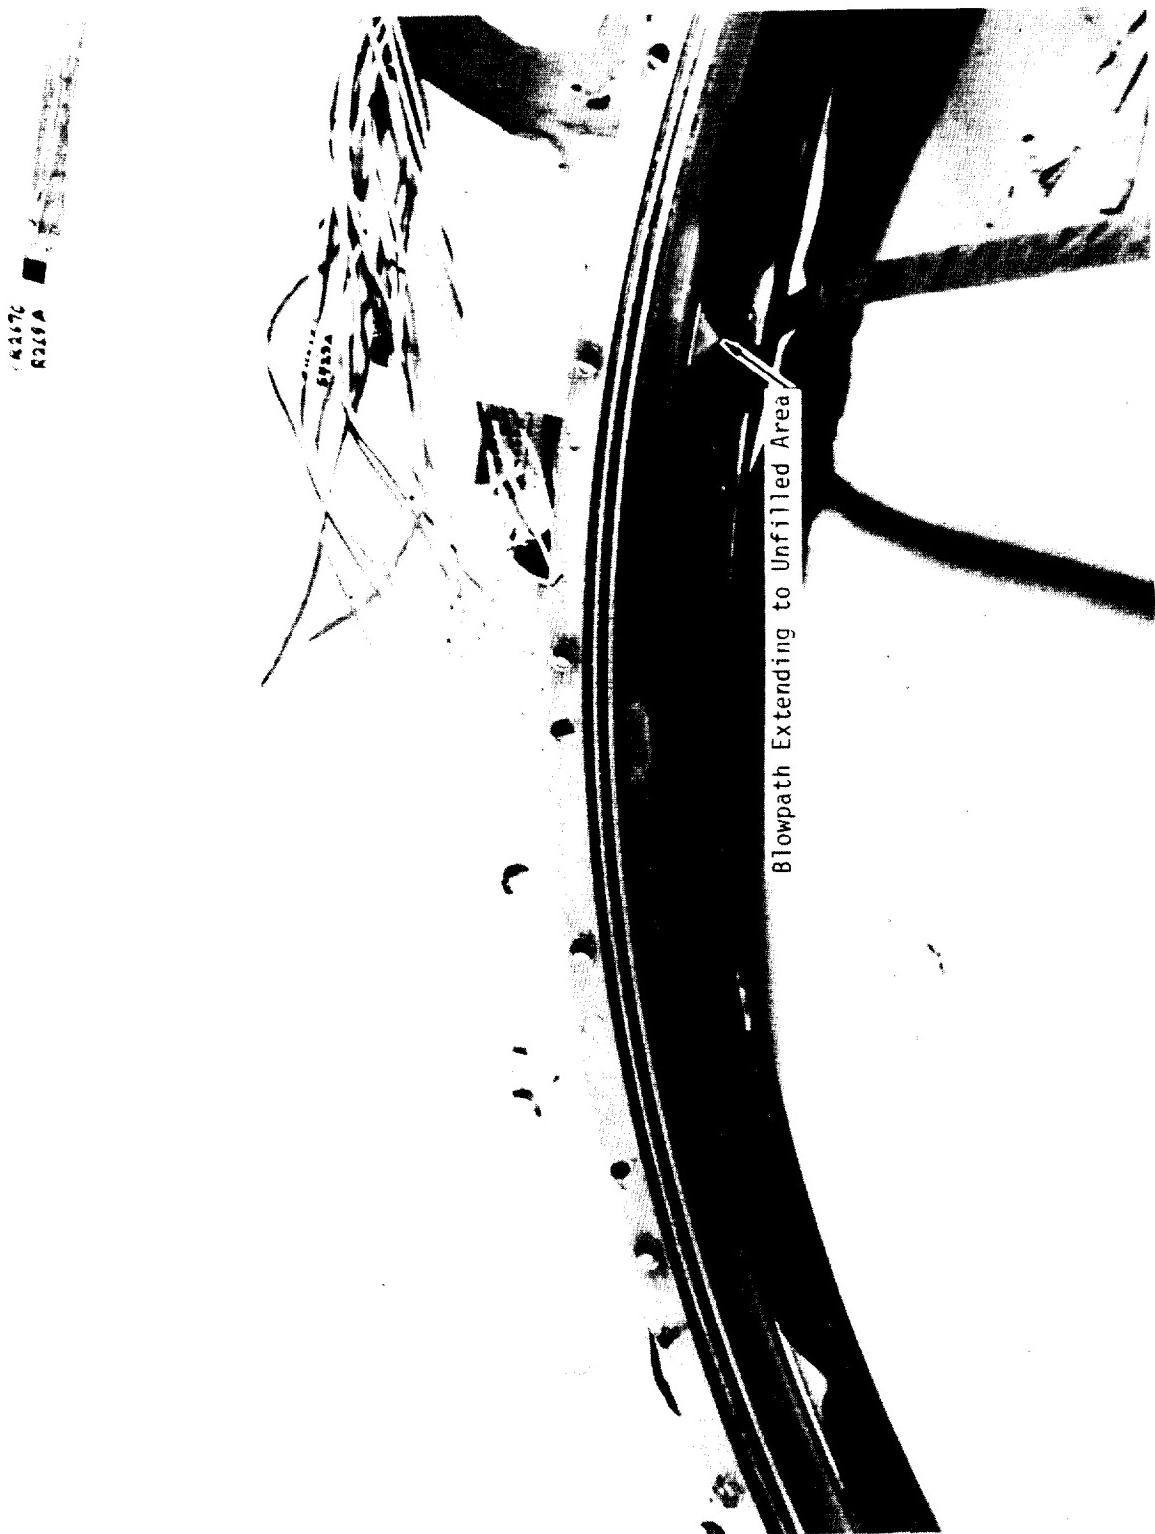
Figure 7.5-86. Nose Inlet/Throat Joint at 90 deg Showing Blowpath Location

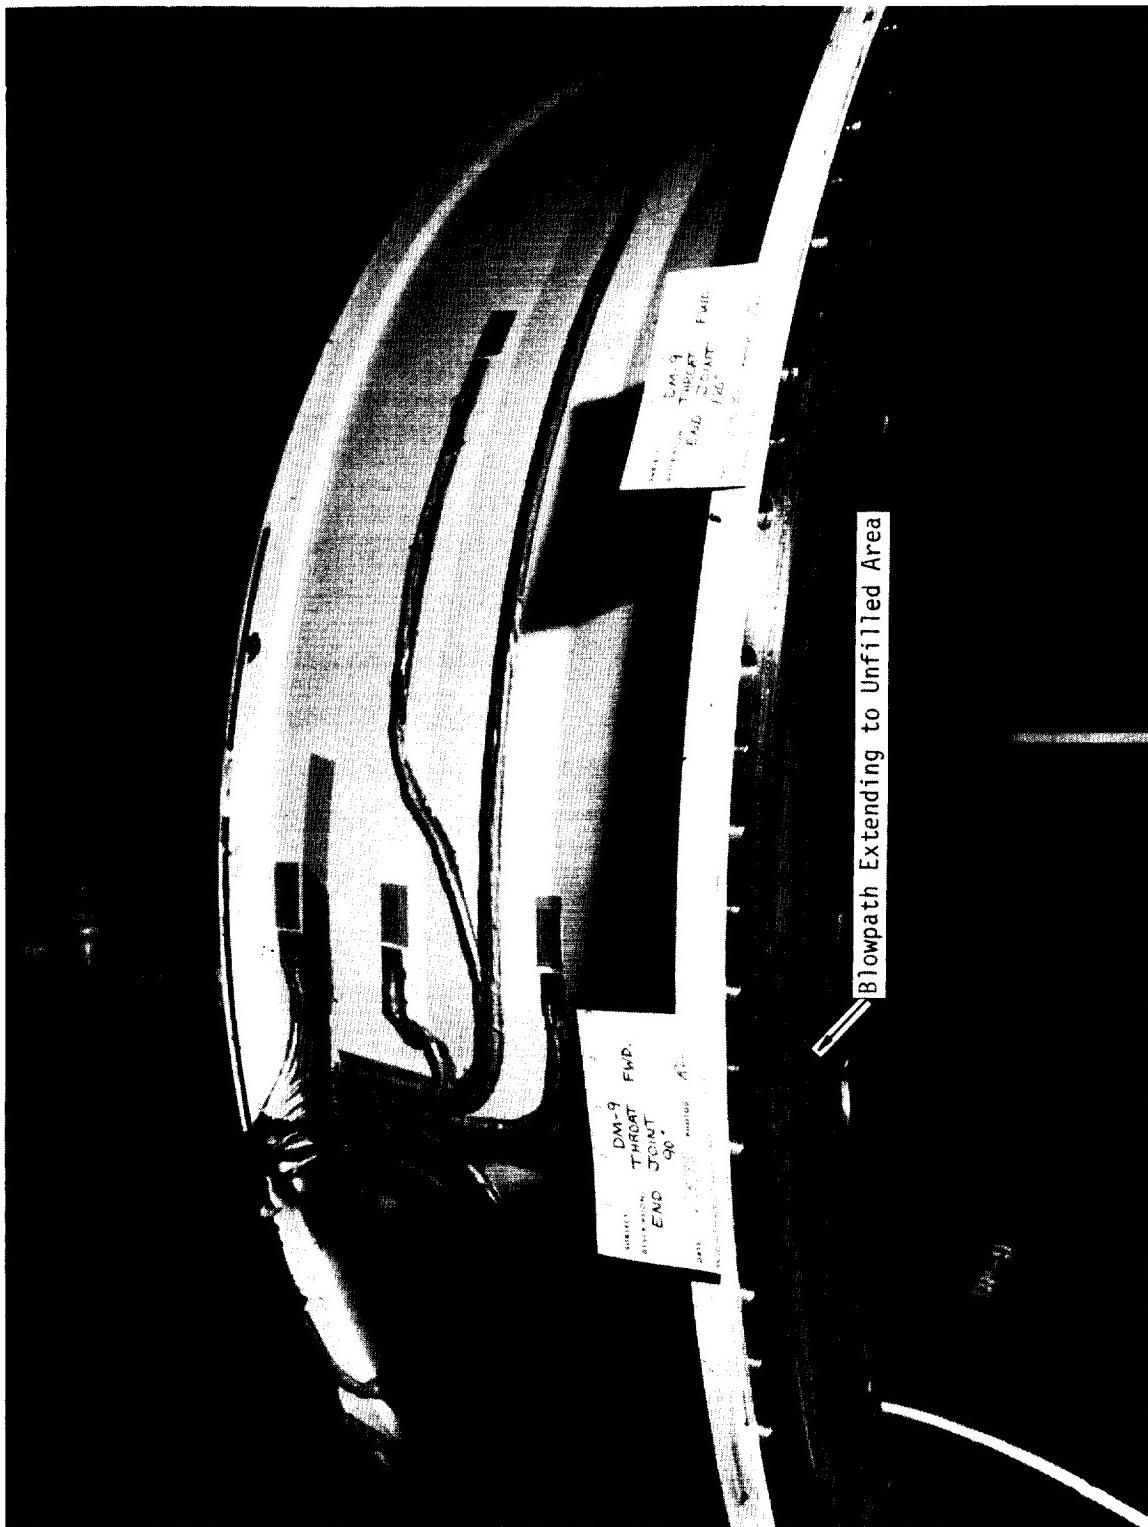
Figure 7.5-87. Nose Inlet/Throat Joint at 90 deg Showing Blowpath Location

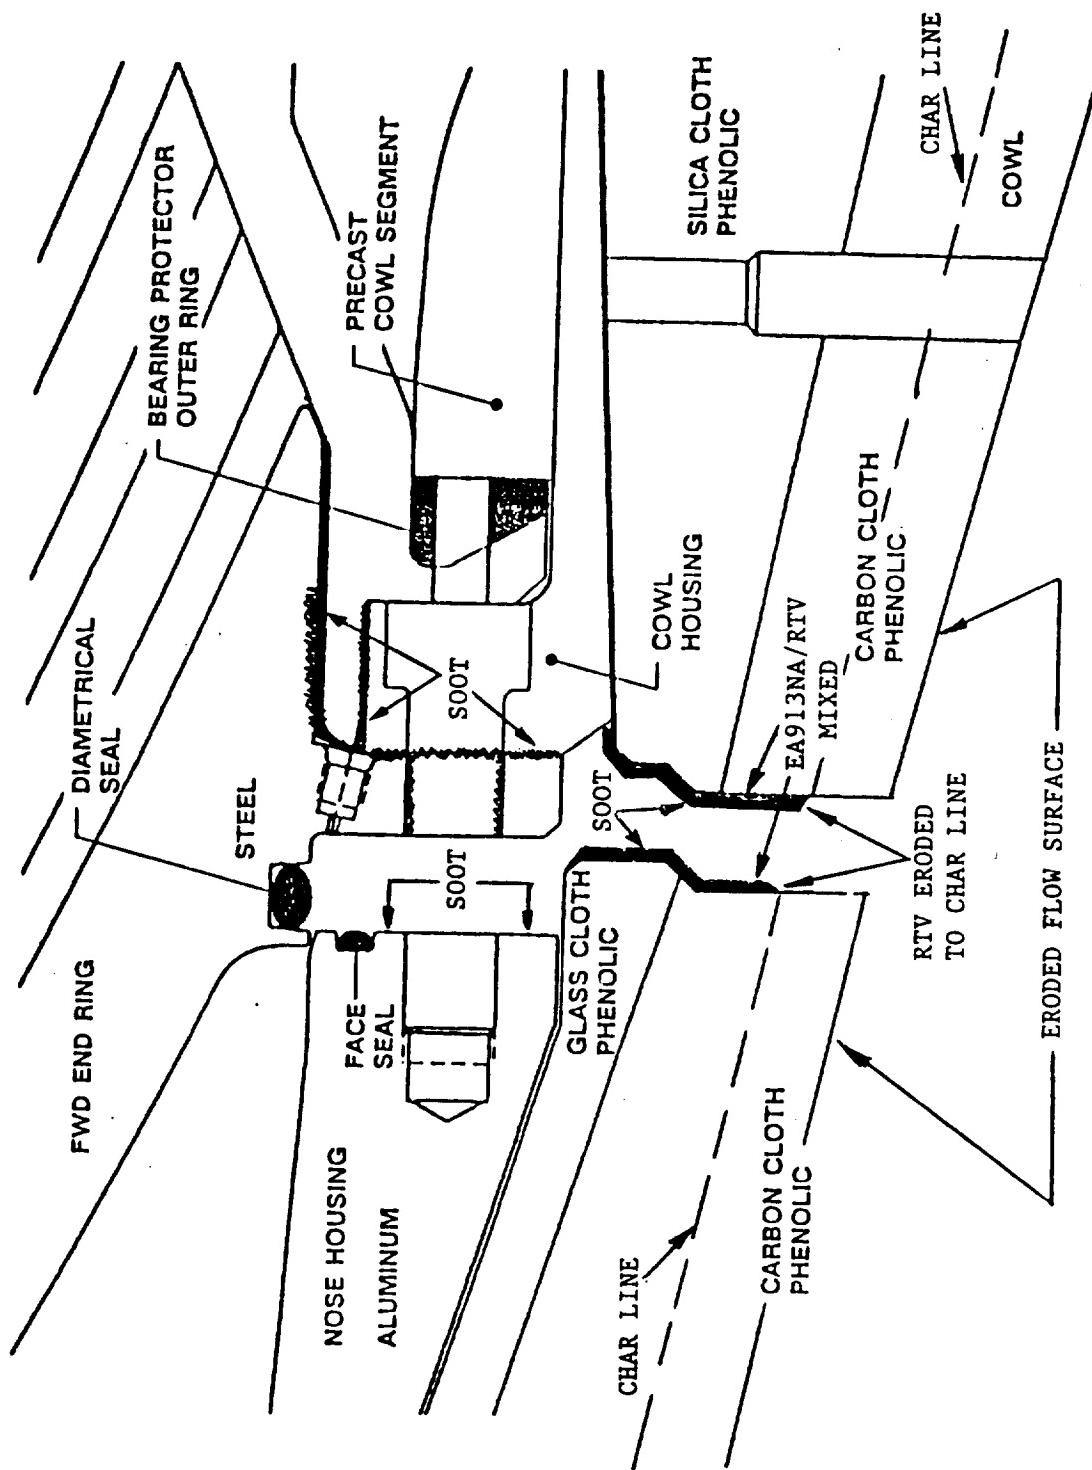
The sealant was eroded to the char line as expected. EA 913NA adhesive was found to be mixed with the RTV. The adhesive was typically between two layers of RTV. Soot was observed between the RTV and adhesive, and also on the metal surfaces of the nose inlet housing and bearing forward end ring up to the bolt holes. The accumulation of soot was heaviest from 15 to 39, 186 to 204, and 280 to 286 deg. Soot also reached the high-pressure side of the primary O-ring from 0 to 7, 12 to 23, 37 to 39, 90 to 92, 105 to 108, 180 to 195, 200 to 210, 240, 290 to 295, 320, 335, and 345 deg. The primary O-ring was exposed to pressure, but showed no signs of erosion or heat effect. In addition, soot was observed between the cowl housing and bearing forward end ring, between the bearing protector and bearing forward end ring (cross section, Figure 7.5-88), and between the cowl housing forward flange ID surface and bearing protector.

Figure 7.5-88. DM-9 Post-Test Nose Cap/Bearing/Cowl Ring Joint

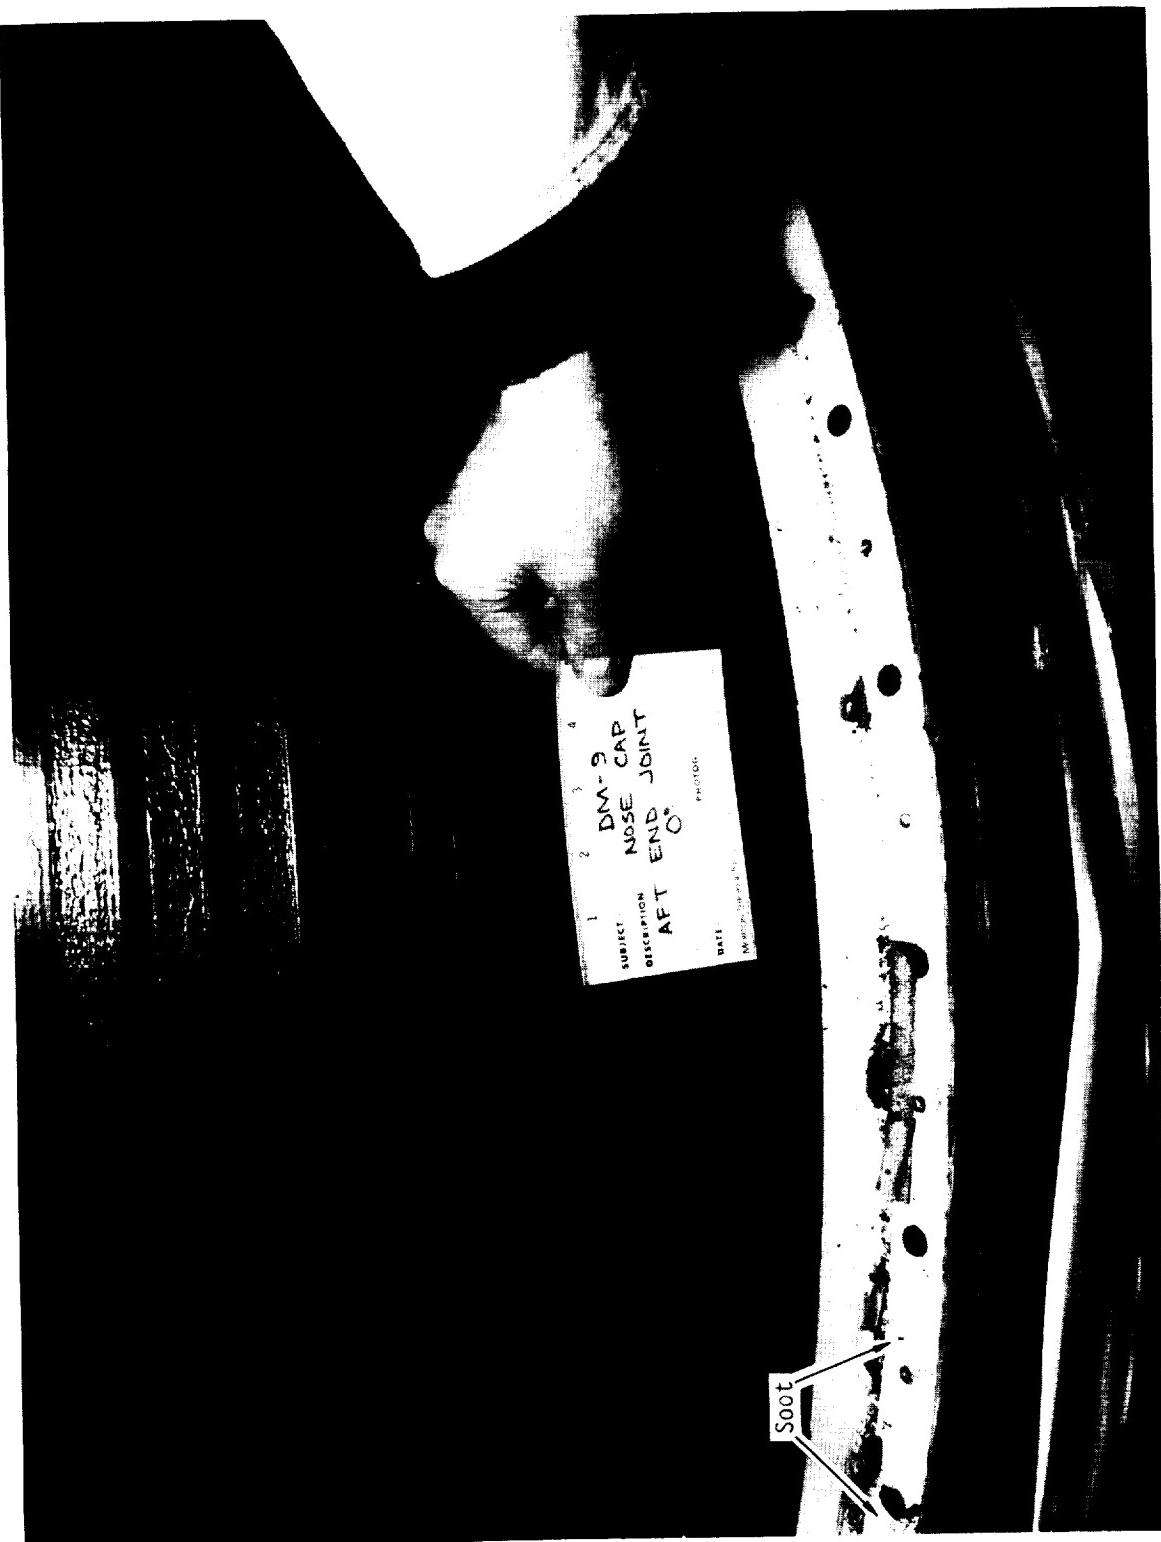
Figure 7.5-89. Nose Cap Aft End at 0 deg Prior to Removal of Flex Bearing
